Two Rods Don't Make It Right: Hyatt Regency Walkway Collapse

Leadership ViTS Meeting
May 2008

National Aeronautics
and Space Administration

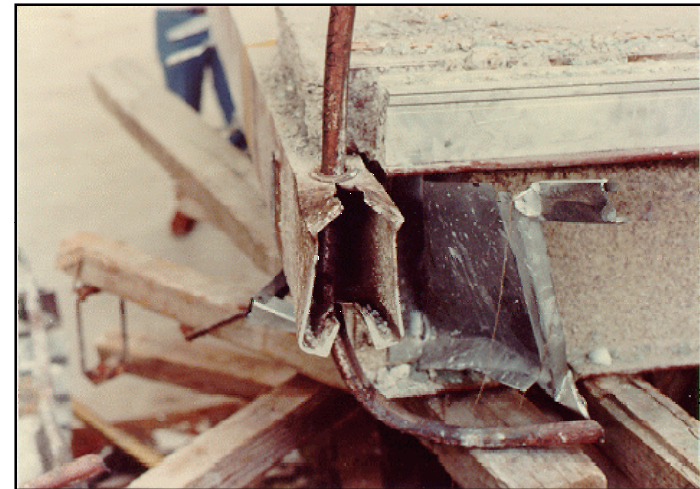
- On July 17th, 1981, guests and spectators filled the lobby and the 2nd, 3rd and 4th floor suspended walkways of the Hyatt Regency Hotel to watch the afternoon “tea dance.”
- Unable to support the load, a support rod connection from the ceiling to the 4th floor walkway ruptured a weld where it penetrated a box beam support element, sparking the progressive failure of all the 5 remaining rod connections sharing, in parallel, the suspended load of both walkways.
- Because the 2nd floor walkway was suspended from the 4th floor walkway, both crashed to the lobby floor in unison.
- 114 people were killed and approximately 200 more were injured.

Ruptured box beam on the collapsed walkway.

- Failure of the box beam weld at the 4th floor walkway box beam and ceiling support rod connection.

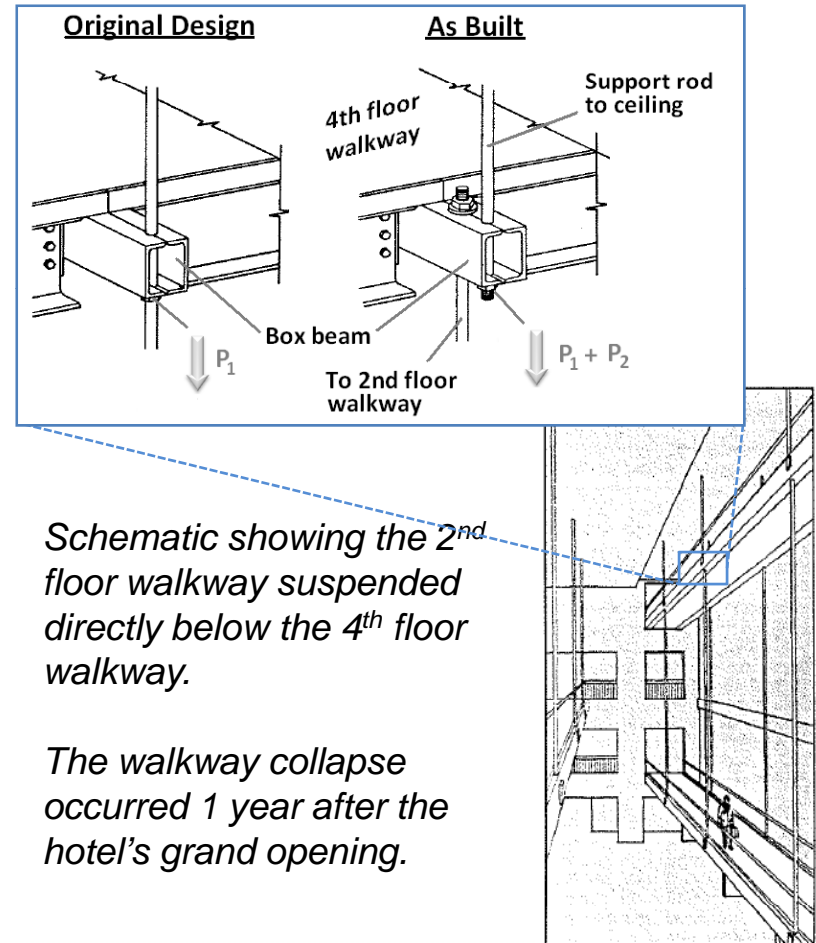
- G.C.E.'s original design intended for both the 2nd and 4th floor walkways to be connected to the same ceiling support rods penetrating through both walkway box beams. The box beam was carrying only the load of one walkway in this design.

- Since this design would require threading the entire length of the support rods below the 4th floor, Havens Steel changed the single-rod design to a two-rod design. Thus, the 2nd floor walkway was suspended directly from the 4th floor walkway (in contrast to the original design) which effectively doubled the load on the 4th floor box beam weld for the support rod suspended from the ceiling.

- There were no records of any calculations, by either Havens Steel or G.C.E., of the new loads or safety factors for the two-rod design change.

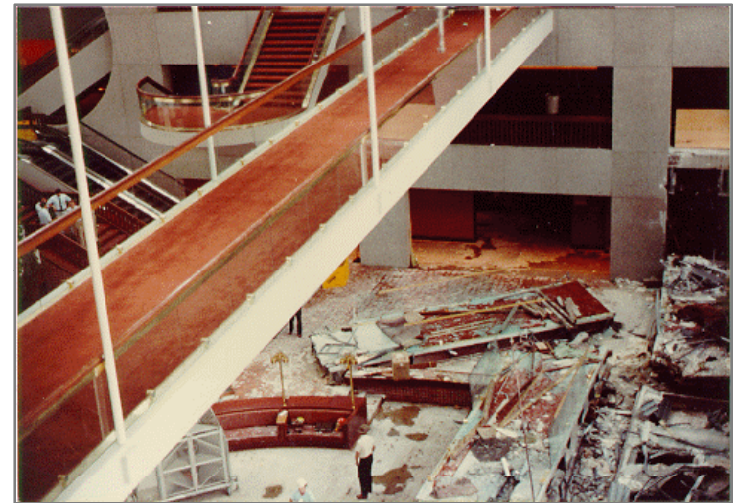
View of the 3rd floor walkway (intact) and the pieces of the collapsed walkways below.
